# Manhole Inspection Summary

Manhole # S21KK1011MH

Insp Date: **11/9/06 10:48 AM**

**Location** Address: **4424 LAPLATA AVE**

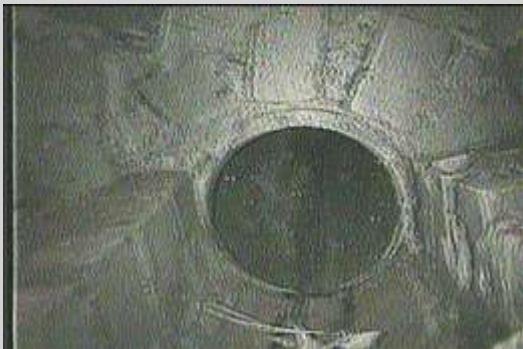
### 6 in. Circular Gravity Sewer Pipe In @ 4 O'Clock

Rod and Bar (Angled)

Pipe Material: **Clay** ☐ Pipe Lined

Infiltration: **None** Pipe Seal Cond: **Unknown**
